## Acoustic Performance – Case Study 5

### Zero4, Plymouth: Hot-rolled steel frame with *Slimdek* floors

SCI P371/5 Zero4, Plymouth

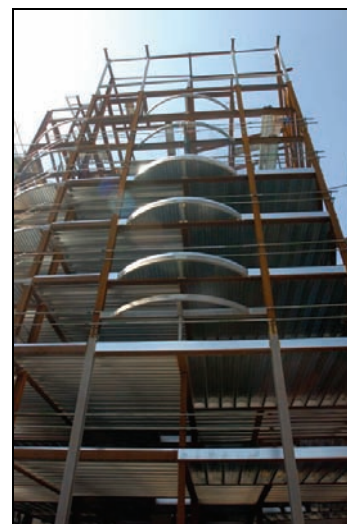
Curved balcony detail

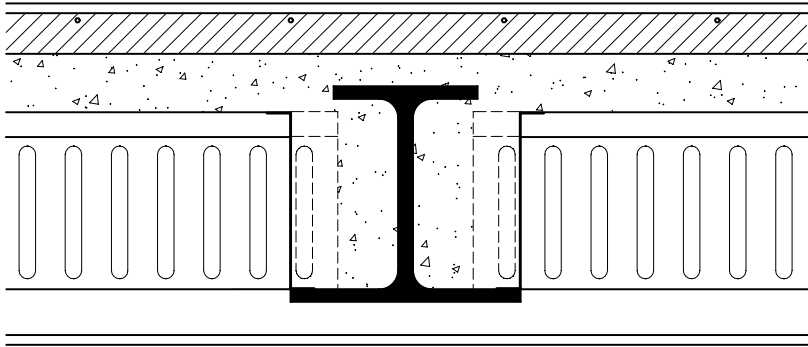
*Slimdek* separating floor construction

### Separating floor:

- 18 mm tongue and groove chipboard
- 75 mm of polystyrene insulation incorporating an under-floor heating system
- 320 mm composite slab formed on SD225 deep decking with steel fibre reinforced concrete (*FibreFlor*)
- The decking is supported on the bottom flange of ASB sections which are incorporated into the depth of the slab
- Void
- 15 mm sound resistant plasterboard supported on a proprietary metal frame system.

The various layers of the separating floors and walls are illustrated in the diagrams below. The acoustic insulation provided by walls and floors is enhanced by isolation of layers, provision of mass and good detailing of junctions. The Corus *Slimdek* floor system uses a composite slab to provide mass and a floor treatment and ceiling to provide isolated layers.

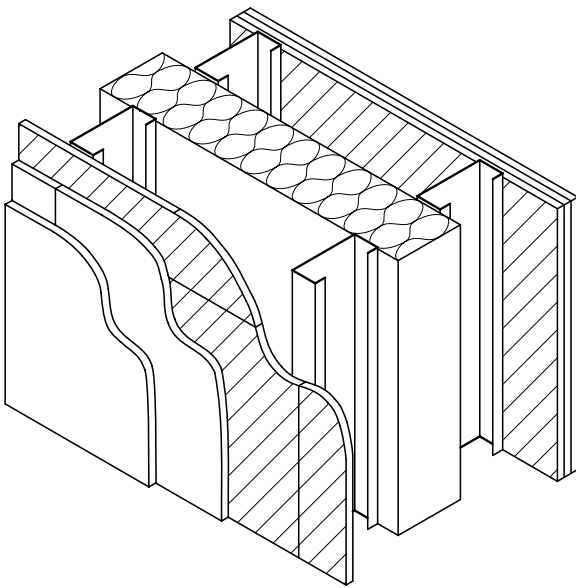
Separating wall construction

### Separating wall:

- Two layers of 15 mm sound resistant plasterboard
- 18 mm of plywood
- 70 mm light steel studs at 600 mm centres
- 50 mm of mineral insulation batts
- The same layer of construction is provided on each side of the mineral wool.

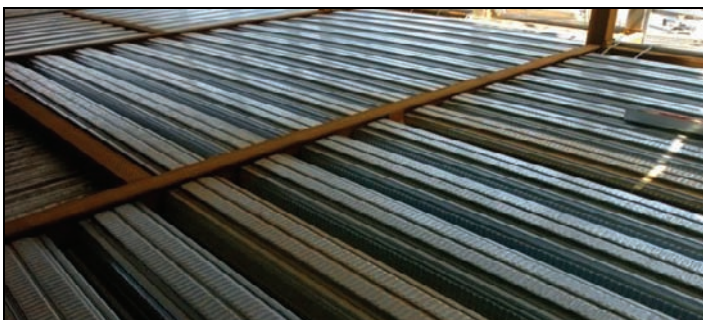
Floor construction prior to concrete placement

The Zero4 development used fibre reinforced floor slabs. Fibre reinforcement can eliminate the need for steel mesh reinforcement, which saves time and has added health and safety benefits through reduced handling and reduced trip hazards.

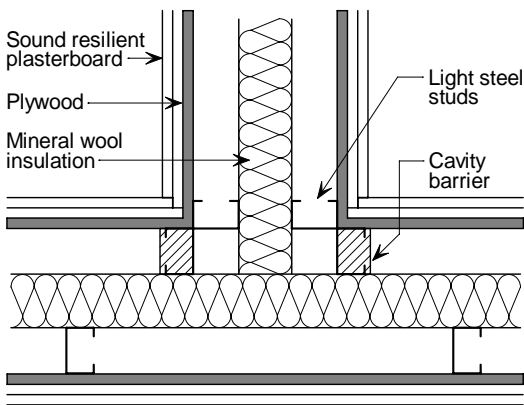
Junction detail between two separating walls

The detailing of junctions between separating walls and floors is important to avoid flanking sound paths which reduce the sound insulation provided between adjacent living spaces. Example details are shown on the next page. Joints between wall and ceiling linings are filled with sealant and the wall boards are not in direct contact with the floor treatment. The plasterboard wall linings are not continuous through the wall junction in any direction. The joints between plasterboard layers are staggered and filled with sealant at the corners.

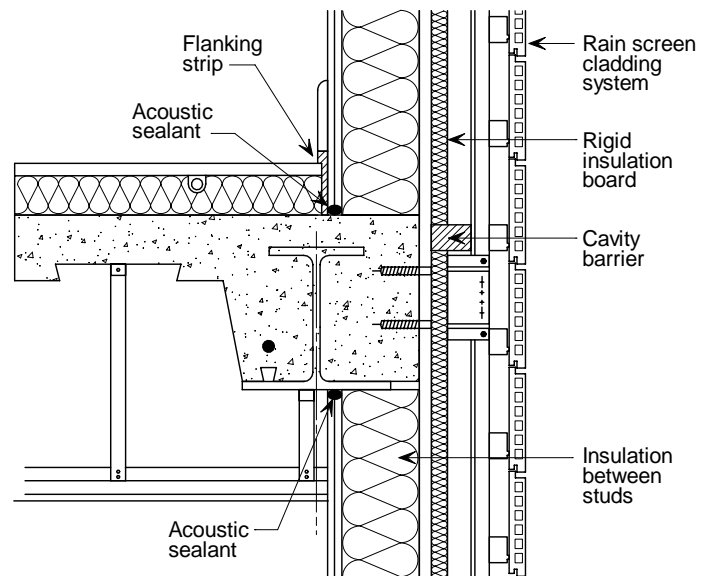
Junction detail between the floor and external wall
