### Classification of Natural Weathering [Type of Panels 2 and 3 – EN 13523-19]

| Panel Identification No & Description | Start of Exposure | Date of Inspection | Accumulative Time of Exposure (months) | Exposure Site & Corrosivity Category (EN ISO 12944-2) | Orientation of Exposed Panel |
|--|---|---|--|---|---|
| 7KK17 – Colorcoat Prisma | 25/2/2008 | 10/03/2010 | 24 months | Sainte Anne BREST (France)<br>Carbon Steel – C5 (Very High)<br>Zinc – C3 (medium) | 90° North<br>and 5° South |
| The coil coated material ref <b>7KK17 (Colorcoat Prisma)</b> may be classified RC5 according to standard EN10169-2 | | | | | |

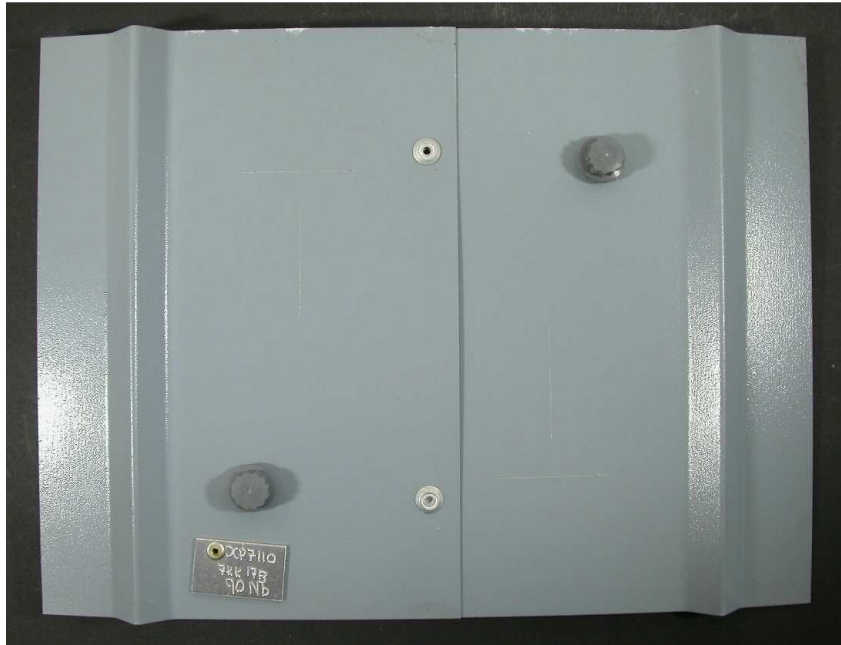
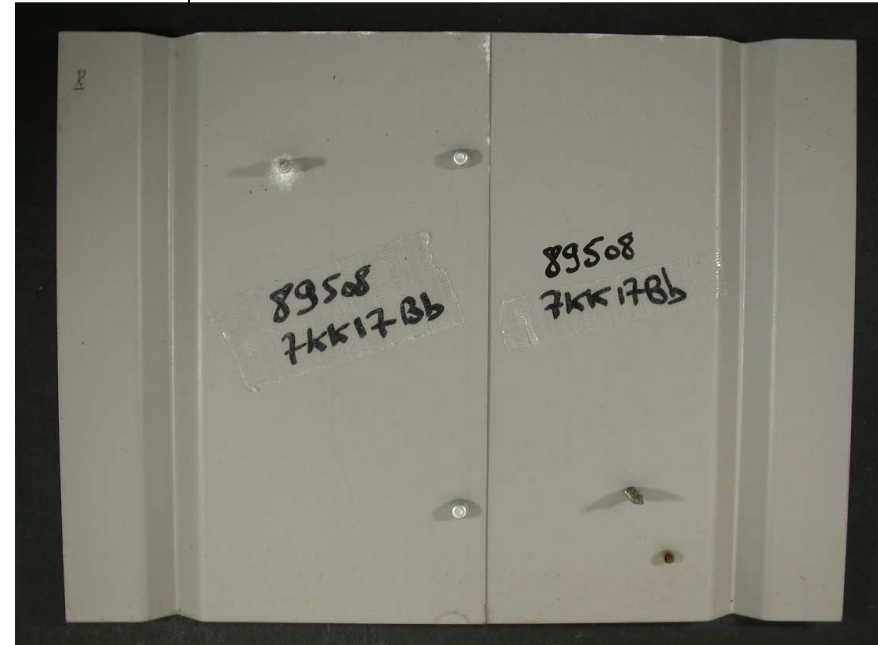
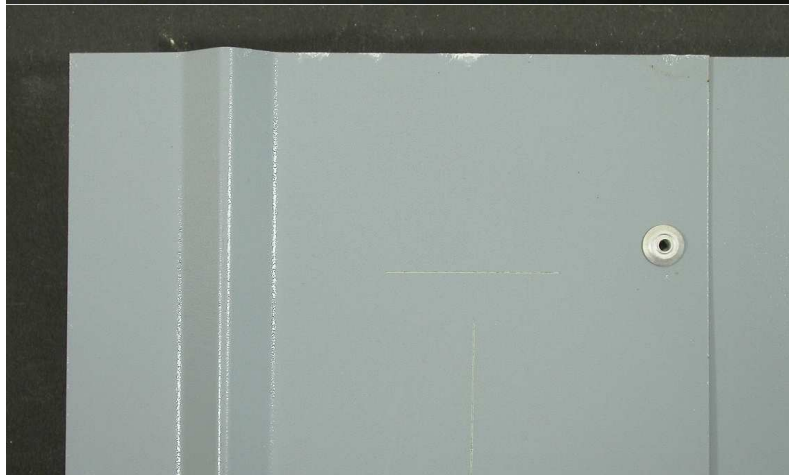
**CORUS 7KK17B.90N**

| Panel Identification No & Description | Start of Exposure | Date of Inspection | Accumulative Time of Exposure (months) | Exposure Site & Corrosivity Category (EN ISO 12944-2) | Orientation of Exposed Panel |
|--|---|---|--|---|---|
| Conforms to RC5 requirements | | Conforms to RC5 requirements | | Conforms to RC5 requirements | |
